**Investigation of Fatal Rental Crane Support Brace Failure
Main Pass Block 255 “A” Platform
OCS-G 07825
June 5, 2002**

**Gulf of Mexico
Off the Louisiana Coast**

**U.S. Department of the Interior
Minerals Management Service
Gulf of Mexico OCS Regional Office**

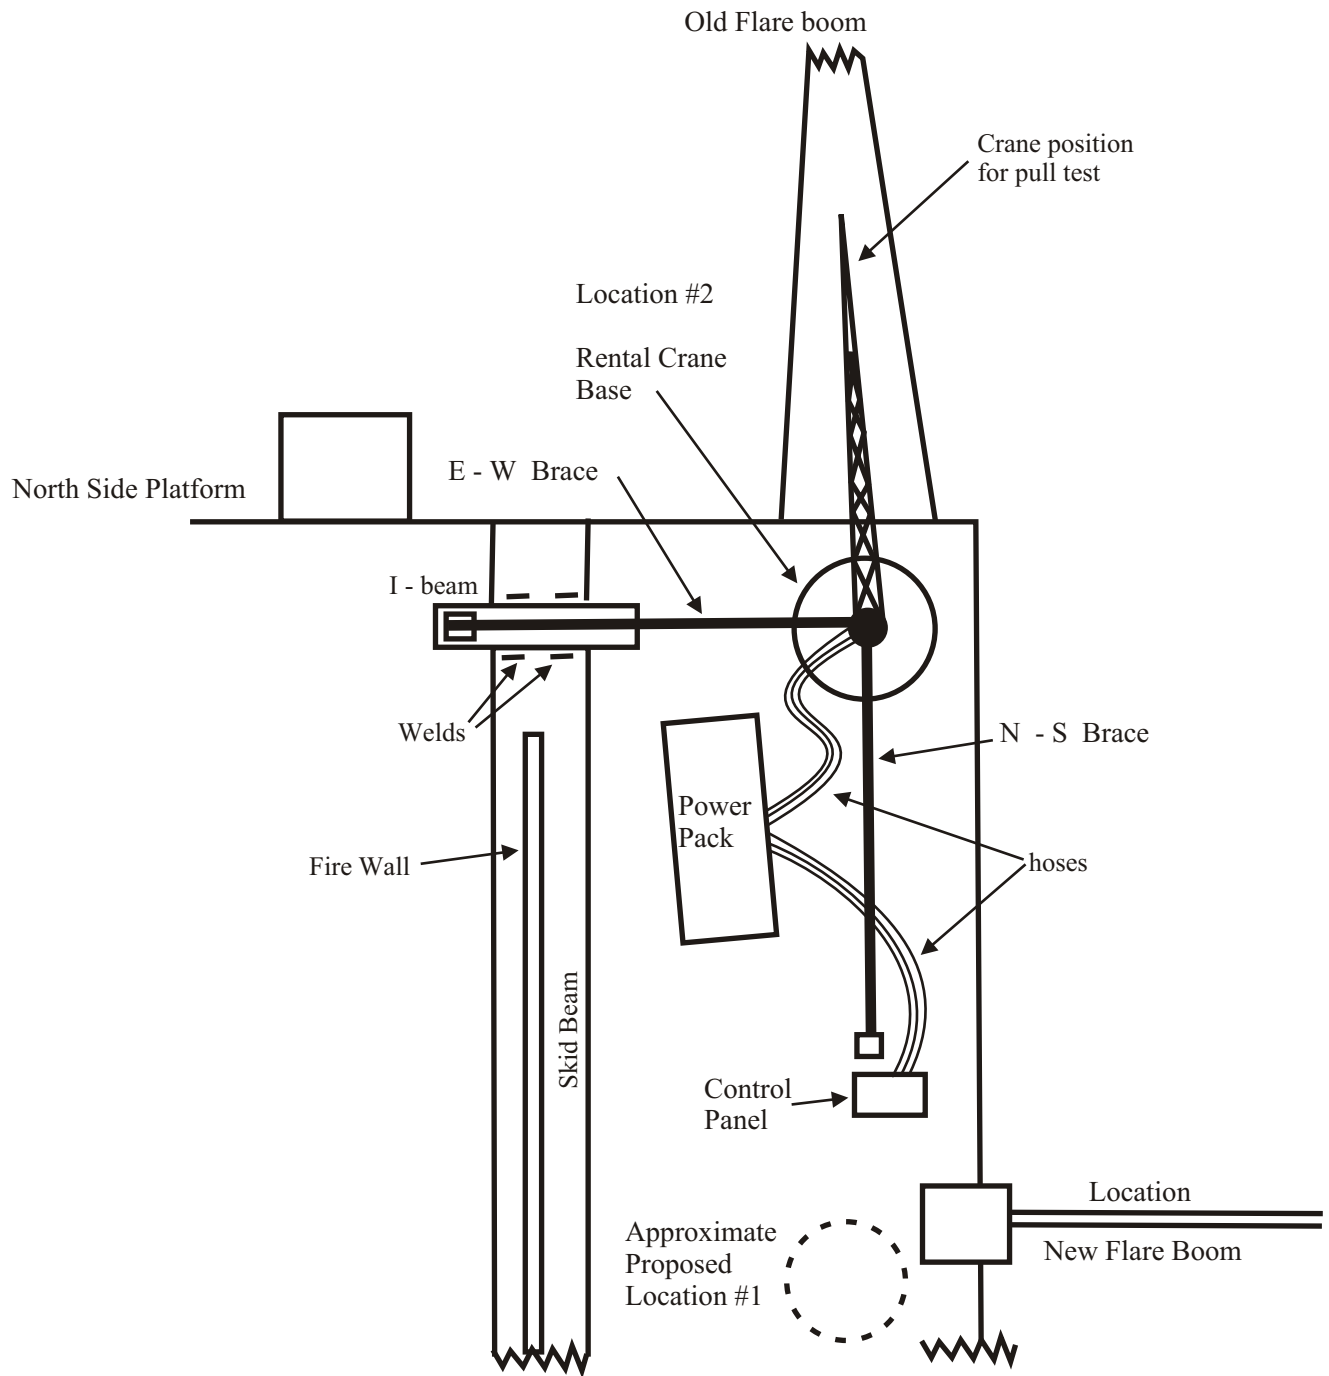
Brief Description of the Accident On the morning of Sunday, 5 May 2002, construction operations were underway to install a new flare boom and to remove the old, 18,000-lb flare boom from Devon's MP-255 "A" platform (*see Attachment 2*). The old flare boom was to be removed from the platform's north side and lowered onto a work boat by using a temporarily installed rental crane. The old flare boom was cut loose from the platform and held by the rental crane. While the load was being swung around the northeast corner of the platform, prior to lowering it onto the boat, the welded base of one of the rental crane's two support braces failed. This caused the crane suddenly to be uprooted from the platform and be pulled overboard into the Gulf of Mexico. The movement of the crane overboard caused the death of one crewmember who was in the path of the falling crane.

Diagram: Portion of Main Pass 255 "A" Platform with Rental Crane Positions.

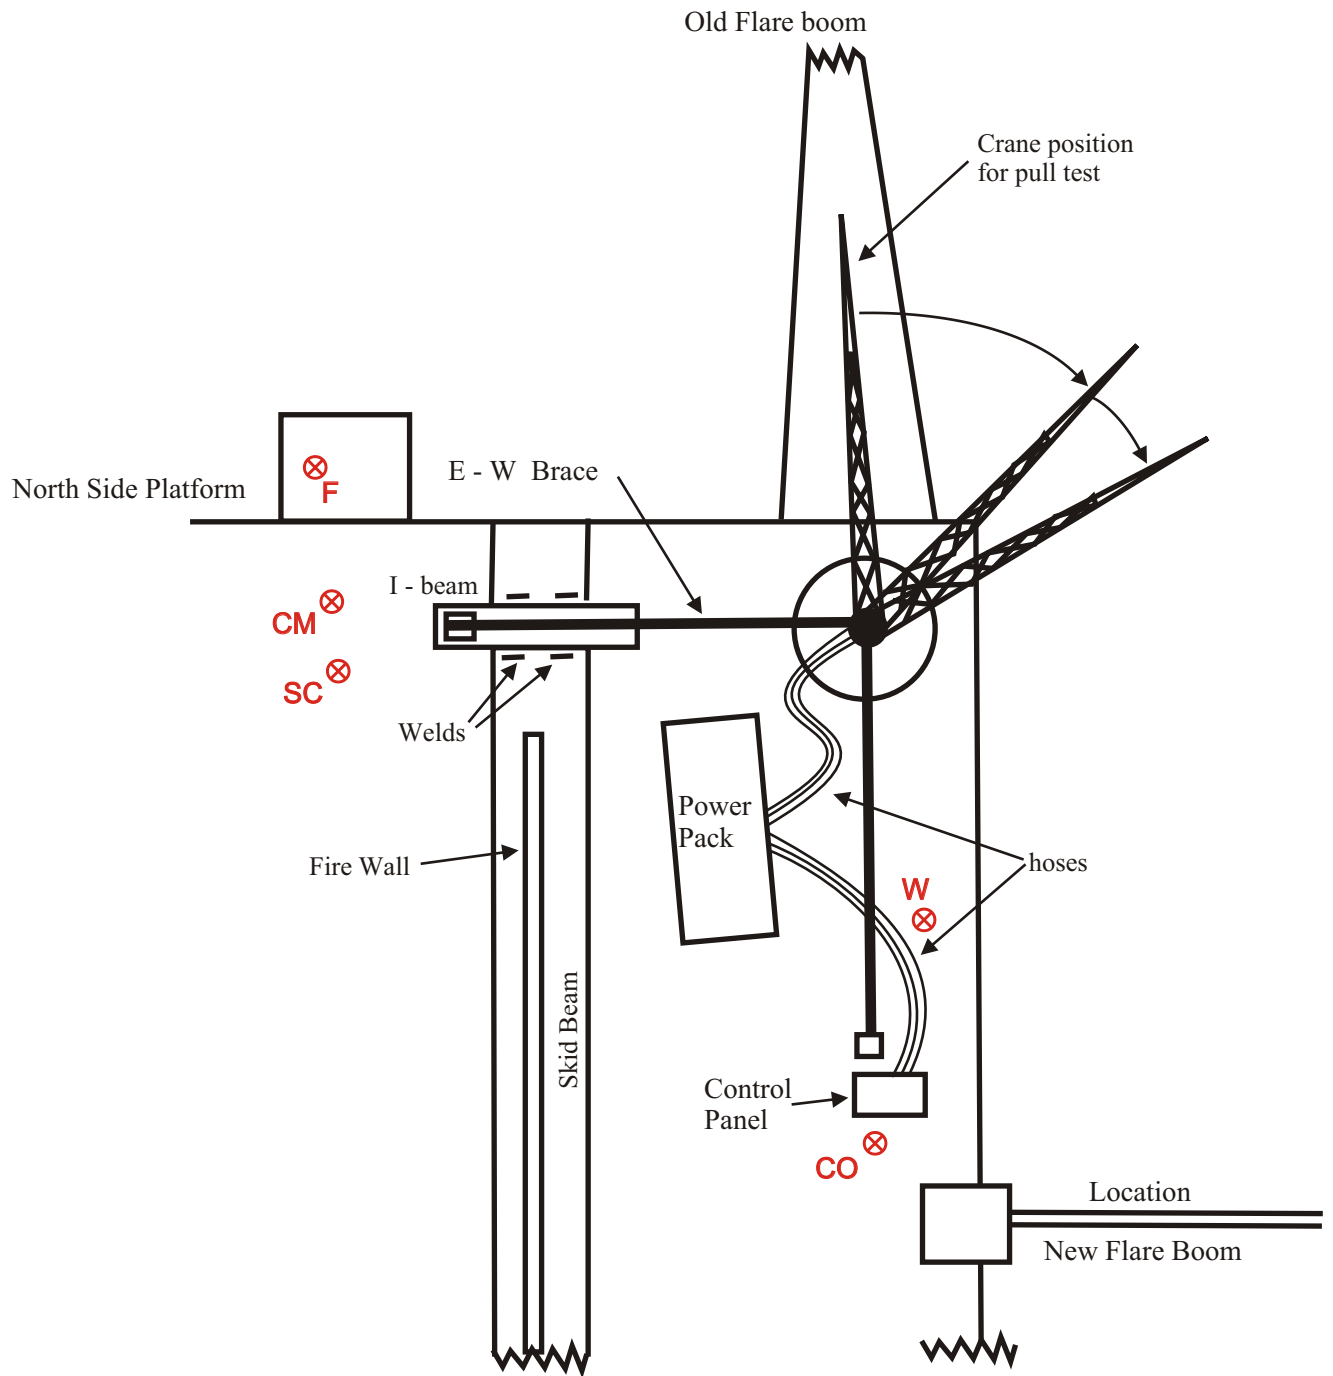
13. At approximately 0800 hrs, as the rental crane boom holding the old flare swung around from roughly a heading of 0° (north) to approximately 50° (east-northeast) (*see Attachment 3*), the E-W crane brace pulled up from the deck.

Diagram: Personnel Locations and Rental Crane Swing Path with/Load.

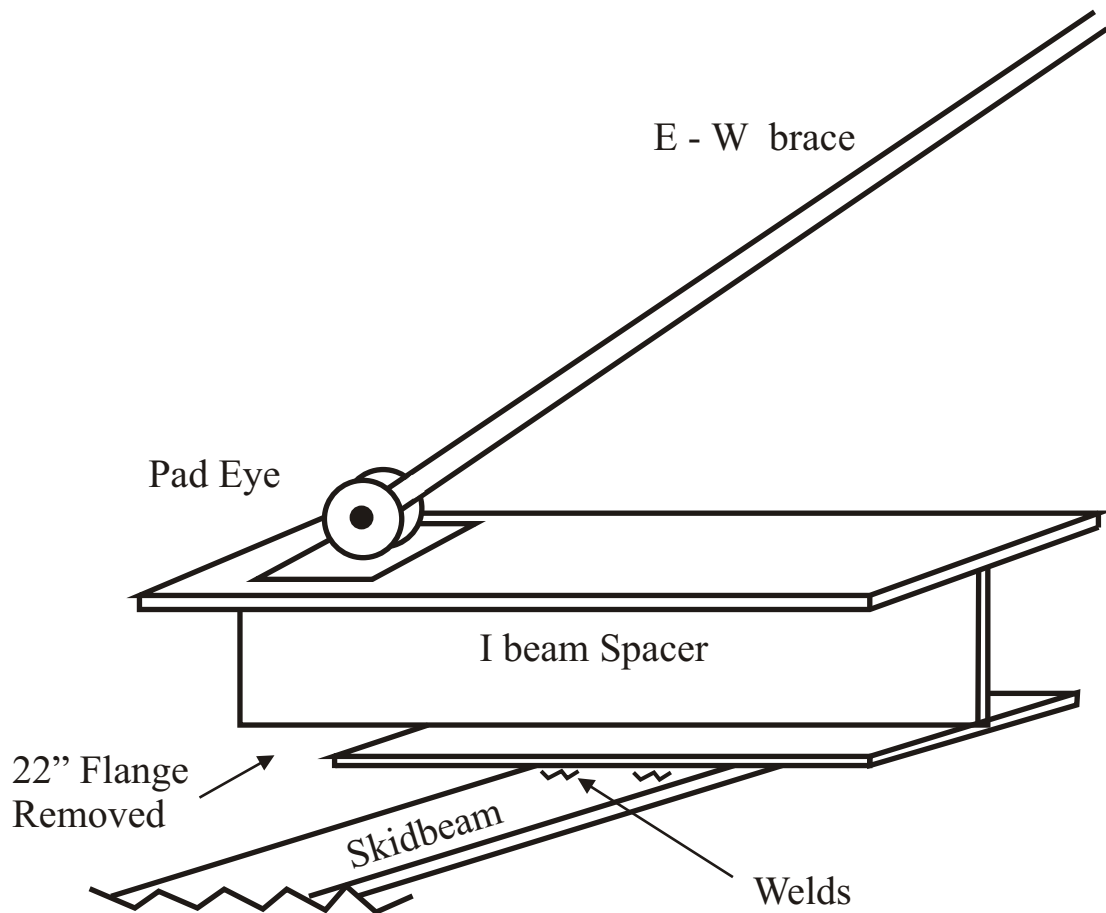
After the new procedure was agreed upon by all parties, the construction crew, supervised by CS-1, set up the crane (*see Attachment 4*). The dimensions and spacing needed to allow the pad-eye base of the two crane support braces (N-S and E-W) to be welded directly onto the platform support beams were measured to determine the location for the king post. The king post was then welded down to the deck and the N-S brace was welded, its pad-eye base being set directly on a support beam as planned. It was then discovered the E-W brace pad-eye overlapped the main skid beam, which was supposed to be its weld point, by about 6 inches (*see Attachment 5*).

This method of setting the crane brace created a cantilever, with the I-beam/E-W brace pad-eye connection being outboard of the I-beam/skid beam welds. This situation allowed a force moment, multiplying the force applied to the I-beam/pad eye connection onto the I-beam/skid beam connection. The I-beam itself had been used as a base for a crane brace several times and was previously modified by the removal of about 22 inches of the bottom flange (*see Attachment 7*). The method previously used was to weld the I-beam onto two or three support beams, thus providing a more stable base than the cantilever employed in this application.

Diagram: Connection of Rental Crane E - W Brace to MP - 255 "A" Platform Skid Beam

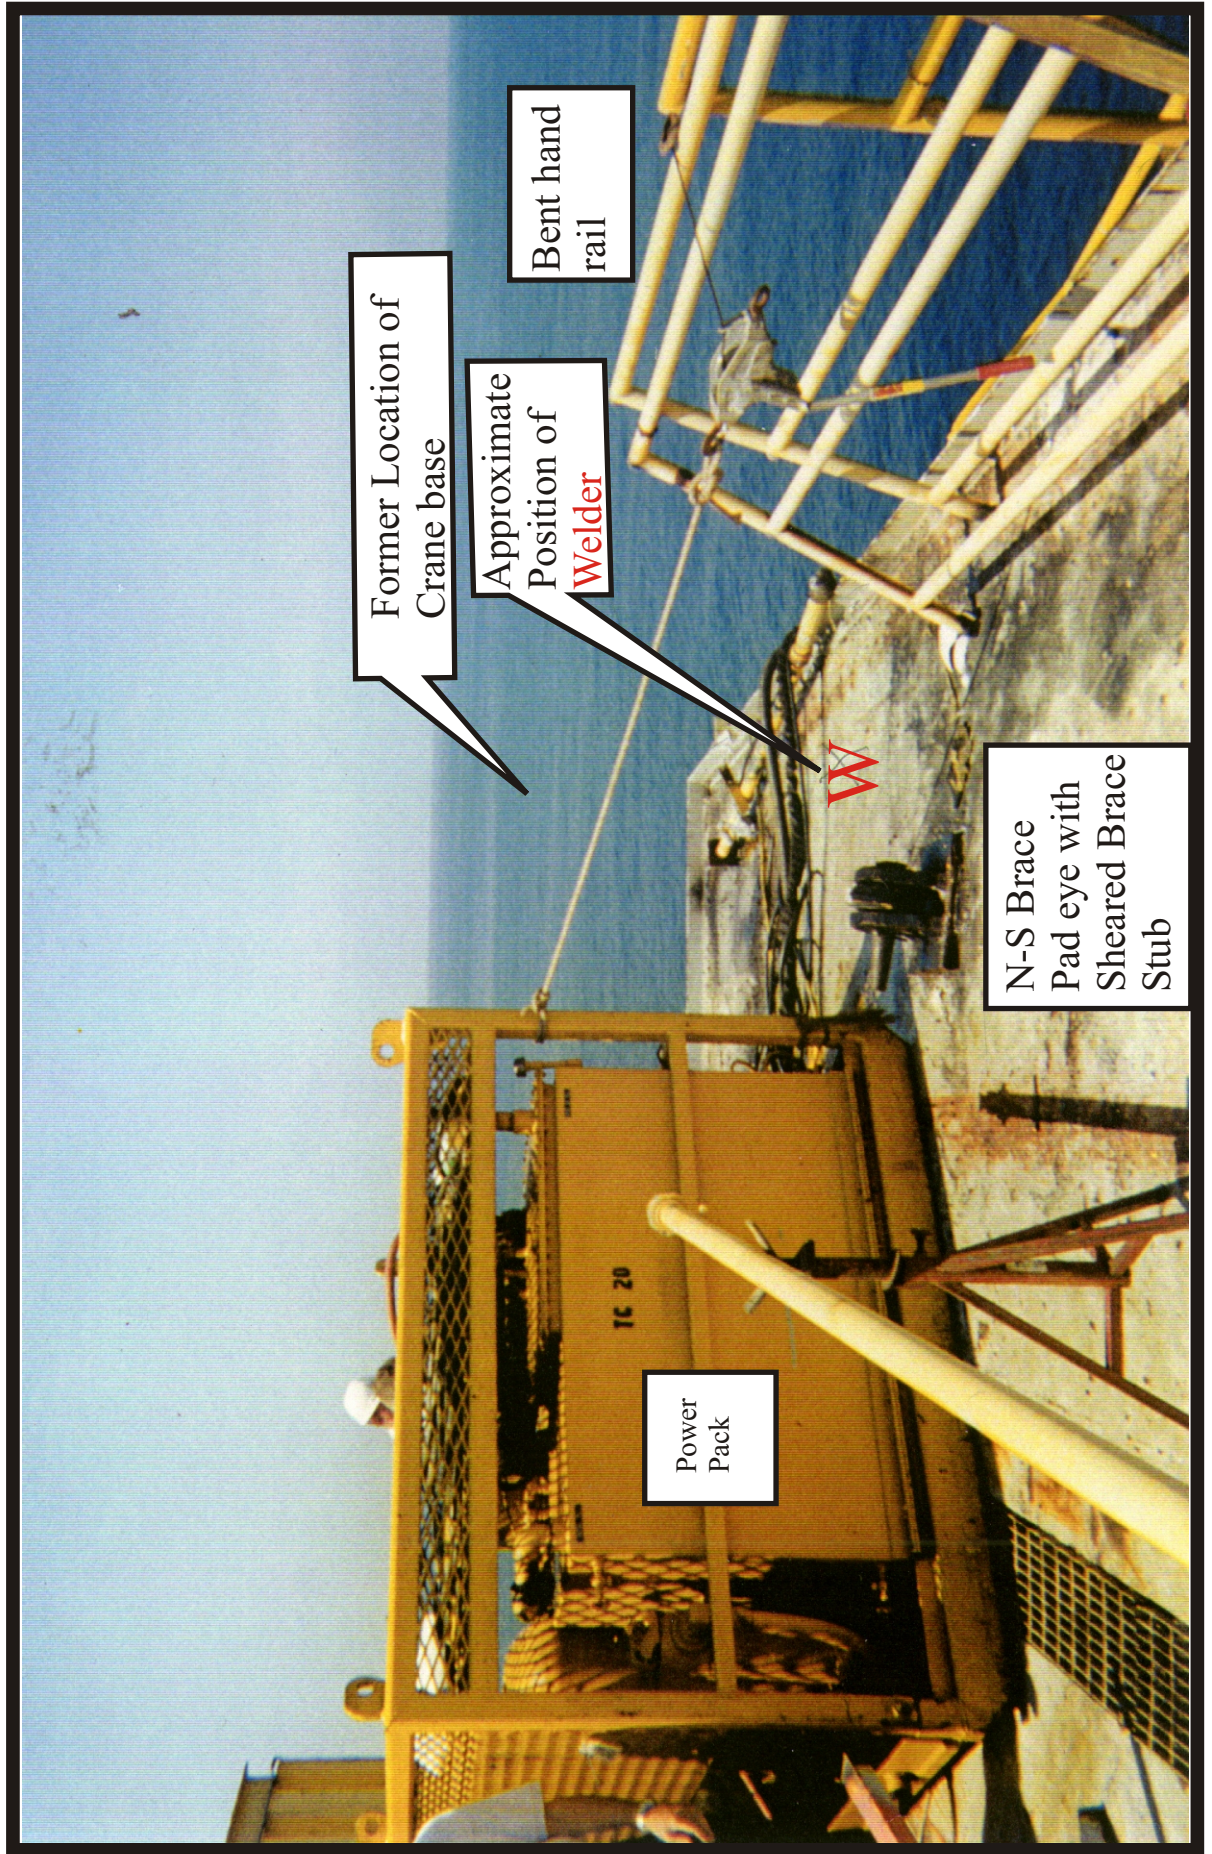
side into the Gulf. (See Attachment 9, picture of platform location of crane after accident.)

The inspection revealed that the I-beam that formed the base for the E-W brace had deformed considerably where the beam was welded to the skid beam of the platform. Portions of the beam flange had deformed and chunks of the flange metal were apparently missing where it had been welded. (See Attachment 10, fillet welds, and Attachment 11, picture of beam and deformation.) The N-S brace had been broken above the pad eye connection to the platform structure,

with the pad eye connection remaining welded to the platform (*see Attachment 9*). The E-W brace had been bent but was intact. With the concurrence of the investigation team, the I-beam and the portion of the skid beam to which the I-beam had been welded, and all pad eye elements, were sent to Anderson & Associates, Consulting Metallurgical Engineers and Testing Laboratory, in Houston, to determine the failure mechanism.

Platform Location of Crane after Failure

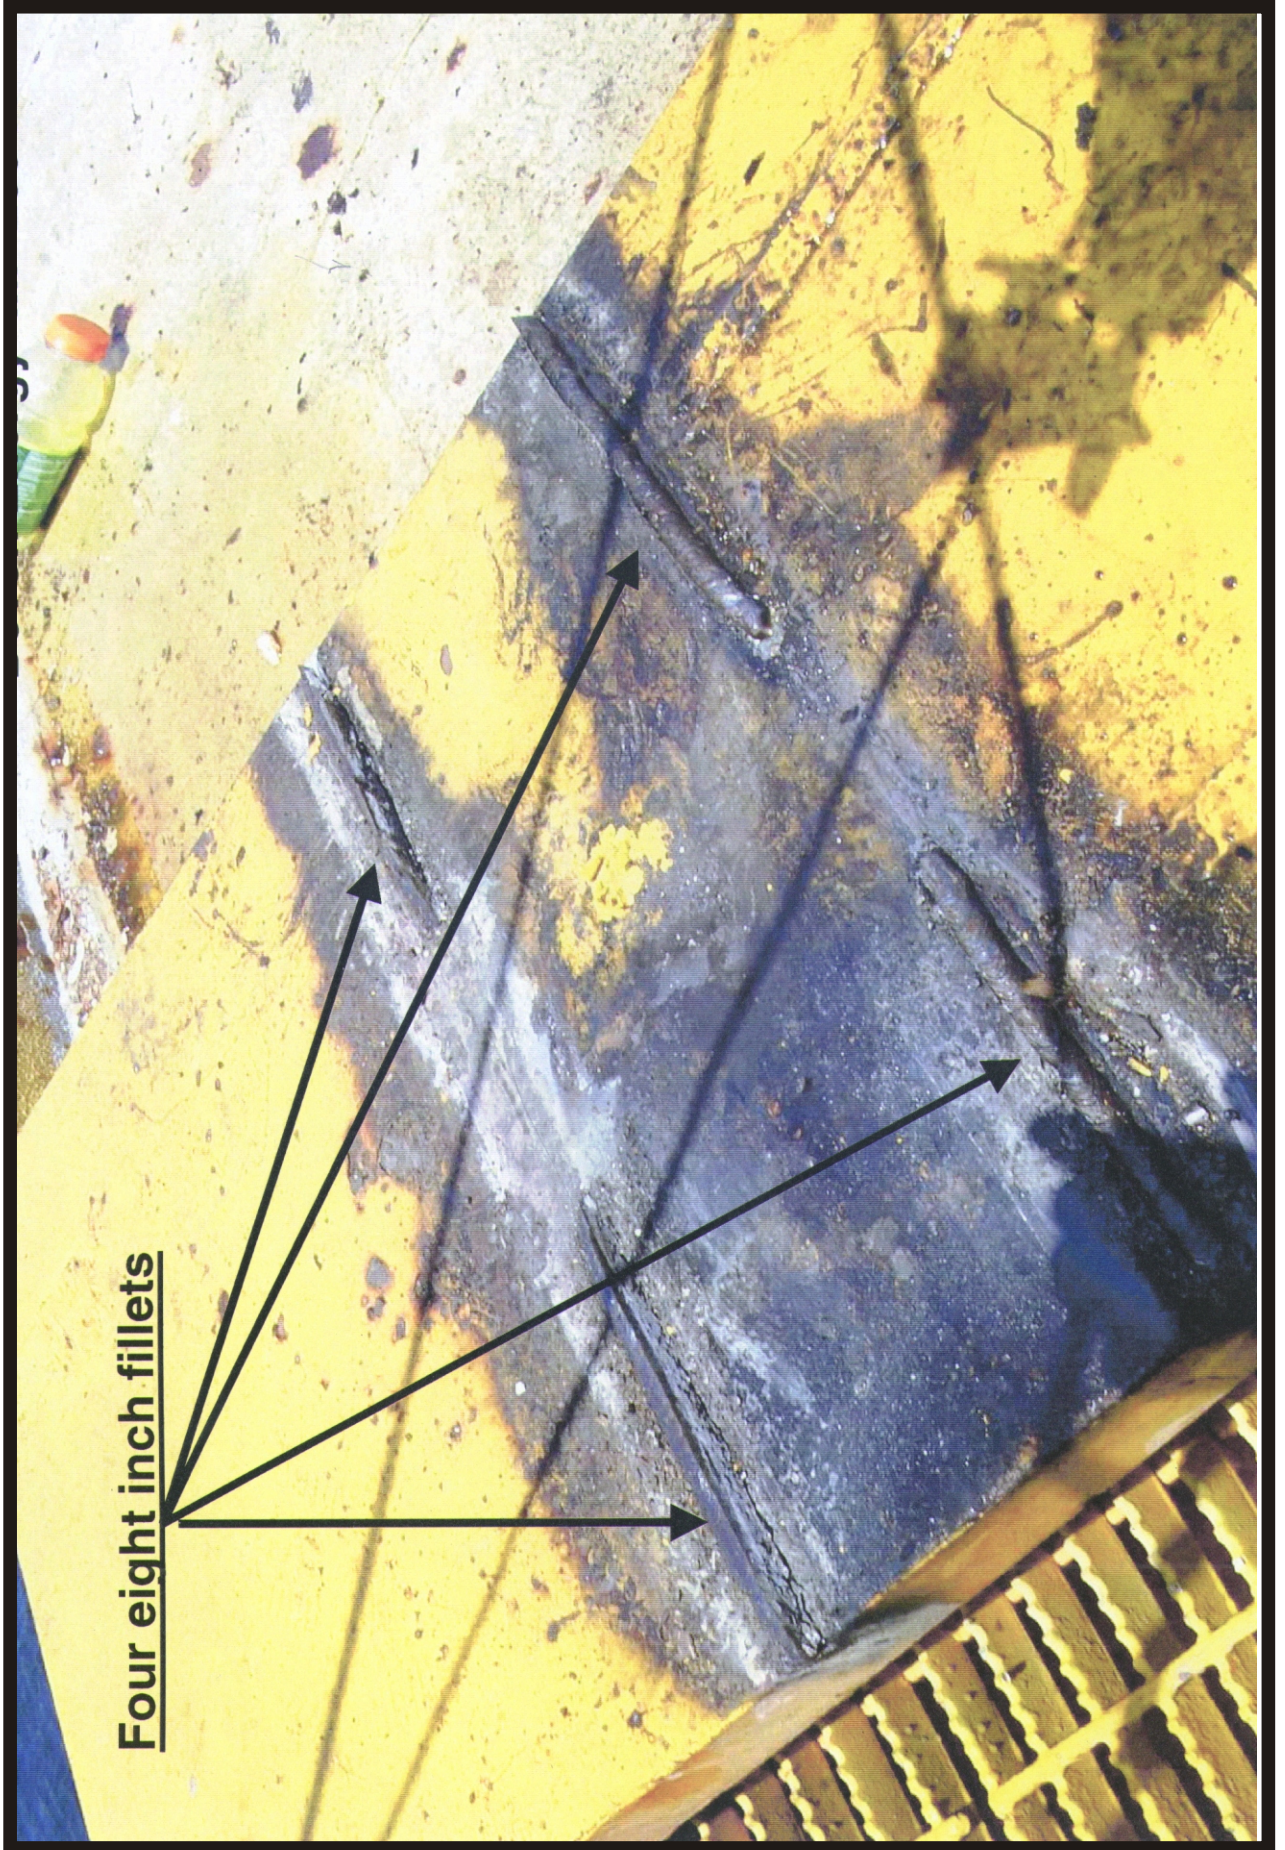
The report noted the I-beam that formed the connection between the E-W brace pad-eye and the platform was placed across the skid beam with the ends of the I-beam hovering in the air, unsupported, forming a cantilever. The bottom flange of the I-beam was attached to the skid beam using four fillet welds. The four

fillet welds failed (*see Attachment 10*). The report noted there was significant deformation of the bottom flange of the I-beam and all such deformation was precisely oriented around the welds (*see Attachments 11, 12, and 13*).

The report stated that it was discovered the materials involved in the failure were basically sound. The I-beam and skid beam were proper structural grade steels and the welds were properly made. The weld fusion was good, the weld was stronger than the metals it attached, and the weld size could not have been any larger because it was limited by the thickness of the I-beam flange. The report concluded the failure of the brace support was completely caused by an overload on the I-beam. The degree of bending of the I-beam flange was such that the fillet welds became loaded more in tension than in shear and the beam itself then failed. The report noted that the failure of the crane brace that led to the accident was caused by the incorrect fundamental design of the attachment of the crane to the platform.

Four eight inch fillets

Fillet weld on skid beam after failure

The MMS recommends to the operators that they thoroughly review the engineering of attaching any rental crane to a structure. The MMS also recommends to the operators that they thoroughly prepare a written procedure that defines the circumstances requiring supervisor, management or engineering review of operations during the course of construction activities. The MMS recommends that formal JSA/JHA's be employed to identify risks to personnel prior to major construction activities.

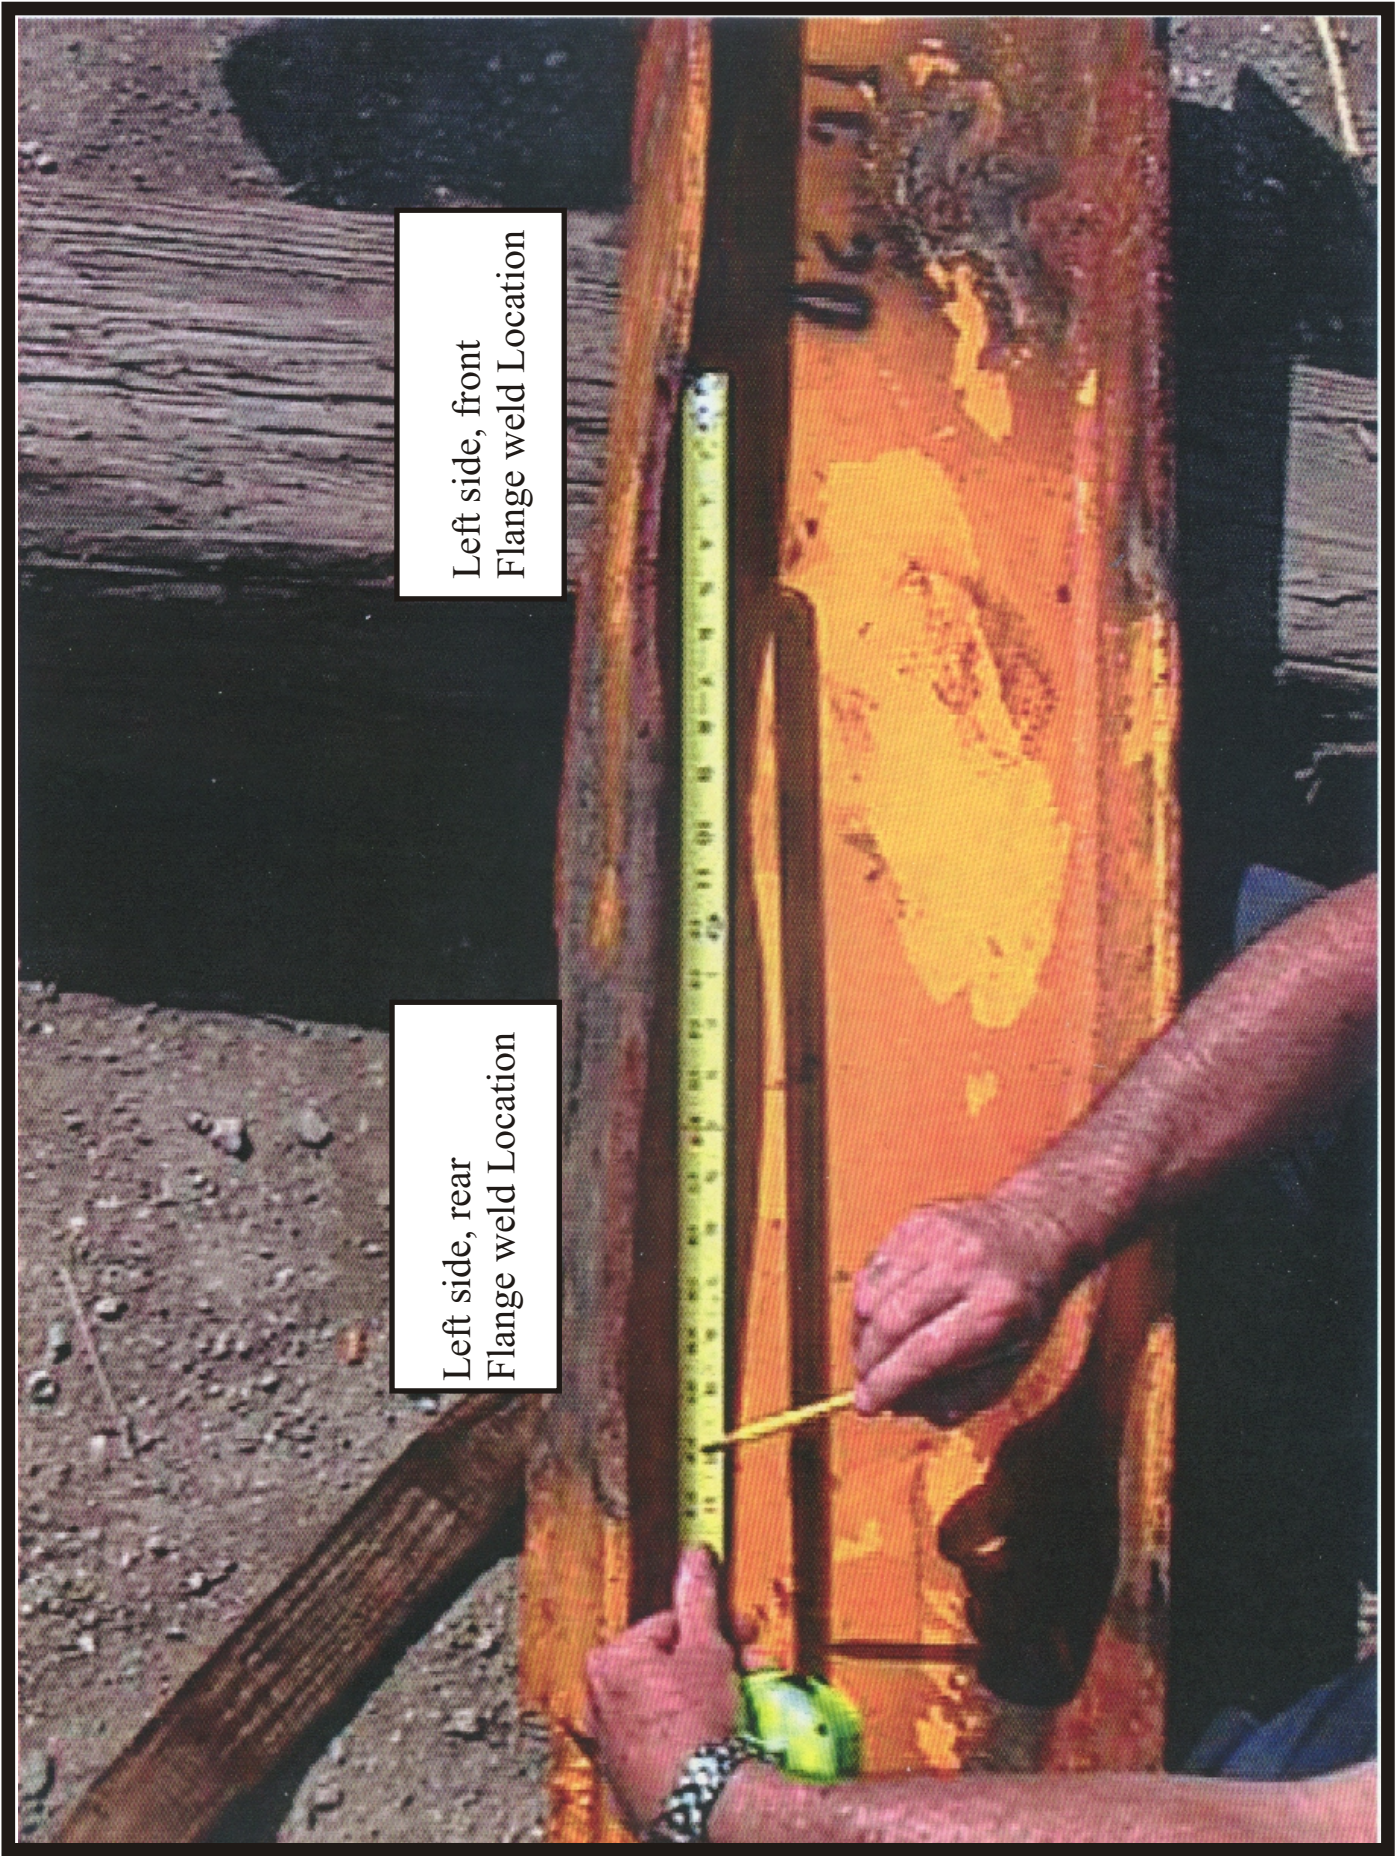
Left side, front
Flange weld Location

Left side, rear
Flange weld Location

Deformation of I-Beam Flange
