Safety Alert No. 321
25 July 2016

Additional Catastrophic Incident Attributed to Ejection of Traveling Slips

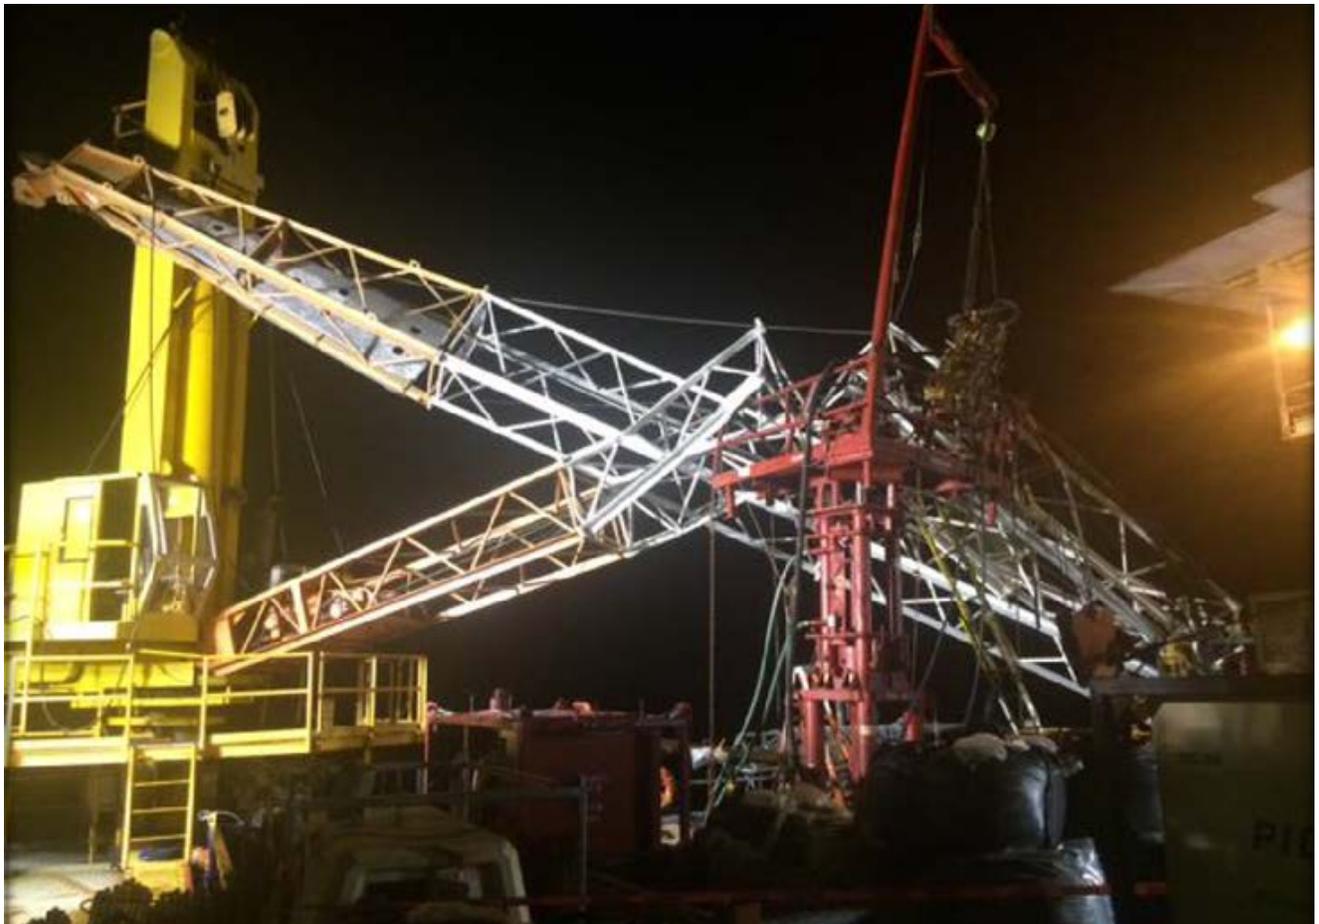
In two separate incidents, a catastrophic offshore accident was caused in part by the ejection of hydraulic pulling unit (casing jack) traveling slips when a bind on the pipe being pulled was suddenly released.

When the work string fell back into the hole, the weight and force of the work string shock loaded the crane because no slips were in place to sustain the weight of the drill collars. This shock loading collapsed the boom causing it to impact the work basket of the hydraulic casing jack. The crane boom then folded in half sending the point of the boom toward the crane operator's cab. The boom point came to rest suspended within 15 ft above the crane operator's cab resting on a single boom stop.

In both events, the traveling slips on the hydraulic pulling unit (casing jack) were dislodged when a bind was suddenly released and the pipe was projected out of the hole. The BSEE recommends the following:

- Before using a hydraulic pulling unit (casing jack), operators should review the equipment to see if the traveling slips can be dislodged during certain operations. If so, BSEE recommends all operators work with hydraulic pulling unit contractors to find a way to prevent ejection of the traveling slips, or mitigate the threat of slip-ejection;

- When using a casing jack to attempt to free stuck pipe, Operators should consider using alternative procedures other than straight over-pull if there is a danger of parting the pipe.

- Operator should always determine if the load is free prior to initiating crane operations to lift a work string during a well abandonment. **UNDER NO CIRCUMSTANCES SHOULD OPERATORS ATTEMPT TO USE A CRANE TO PULL/LIFT A WORK STRING OR LOAD NOT FREE TO BE LIFTED.**
